IN RE: ETHICON, INC., PELVIC REPAIR SYSTEM PRODUCTS LIABILITY LITIGATION	Master File No. 2:12-MD-02327 MDL 2327
THIS DOCUMENT RELATES TO: <i>Wave 3 Cases</i>	JOSEPH R. GOODWIN U.S. DISTRICT JUDGE

Intentional Oxidation of Prolene Mesh – Part 2

Supplemental Report of Dr. Shelby F. Thames

September 28, 2016

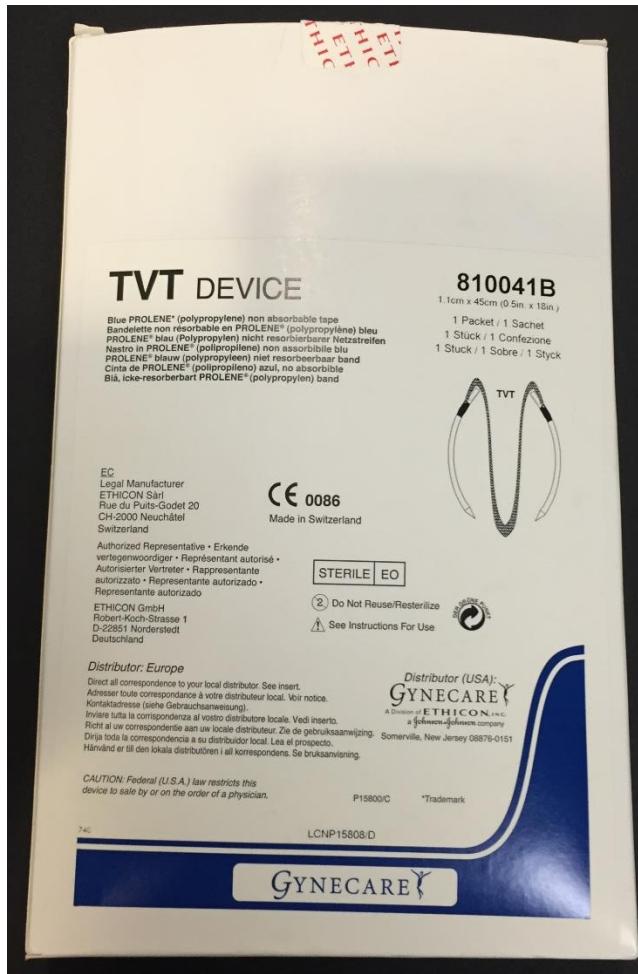
Figure 2. Exemplar Gynecare TVT Device 810041B

A sample size of approximately 10 mm x 10 mm of the exemplar TVT device, lot 810041B, as noted in Figures 2 and 3, was placed in the UV exposure chamber (Figure 4).

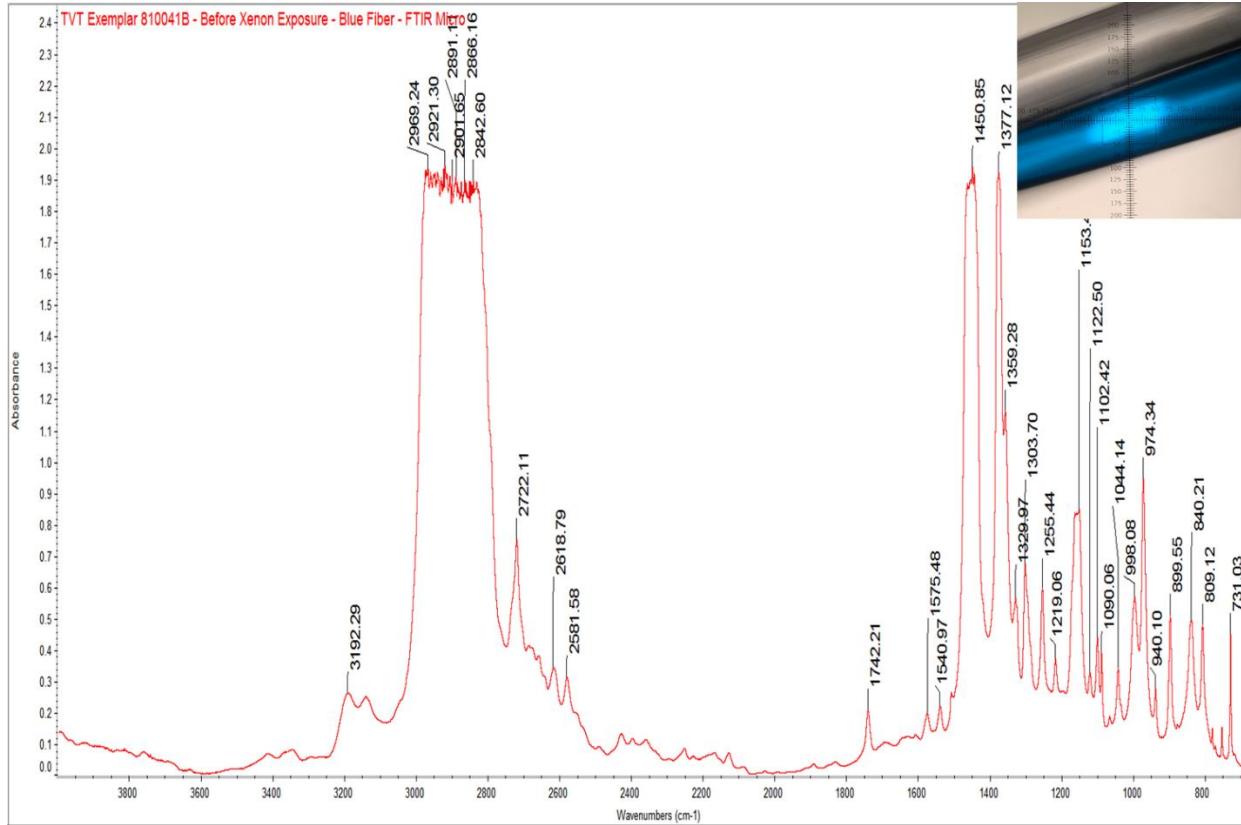
Figure 6. Pristine TTV Exemplar 810041B – Before Xenon Exposure – Blue Fiber

The pristine TVT exemplar sample was characterized via Fourier Transform Infrared Microscopy (FTIR) with a Thermo-Nicolet Continuum FTIR Microscope (Figure 5) prior to UV exposure. The resulting spectrum (Figure 6) contains an inset image showing the penetrating IR beam location. The absorption frequency at 1742 cm^{-1} , indicative of Ethicon's DLTDP antioxidant, is also noted in my previous reports, which I rely upon, and is present in the spectrum.

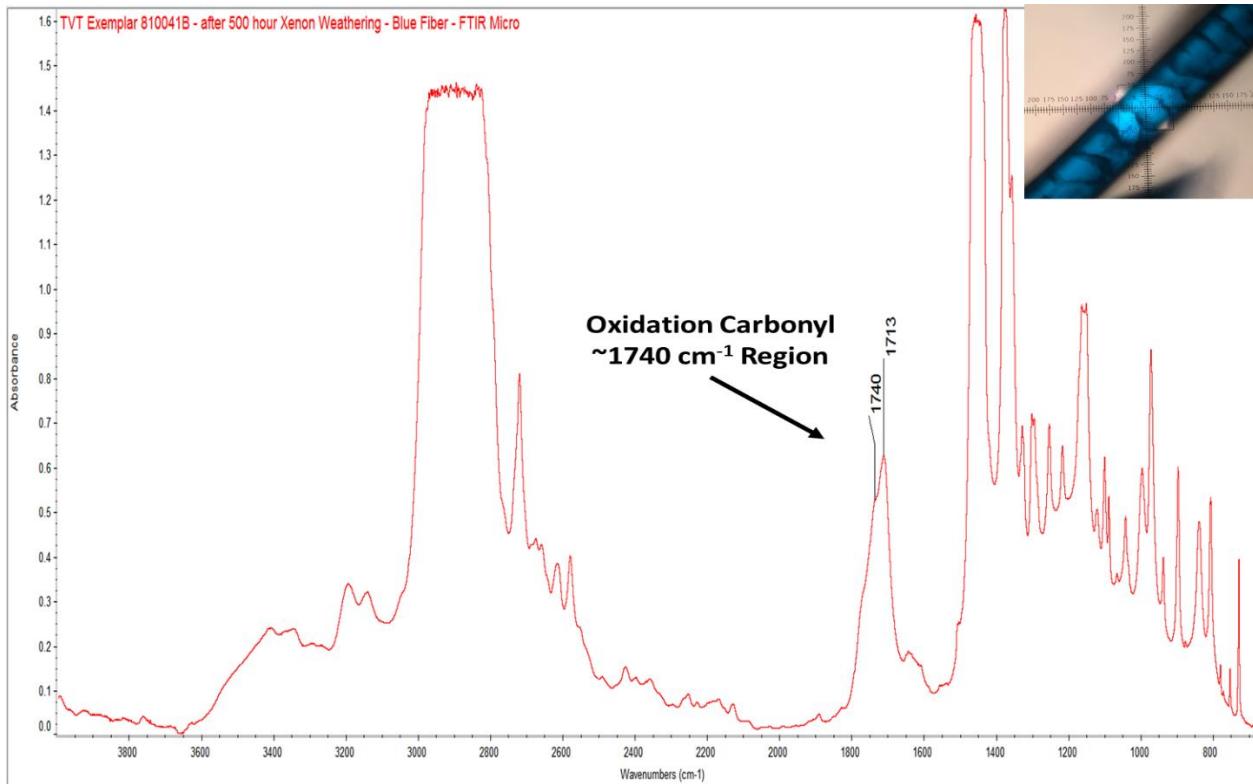
Figure 7. TTV Exemplar 810041B – After 500 hrs. Xenon Exposure – Blue Fiber

After 500 hrs. UV exposure the TTV exemplar was removed from the exposure chamber and again characterized via FTIR Microscopy (Figure 7). Oxidative degradation is evidenced by the presence of strong carbonyl absorption frequencies in the $\sim 1740\text{ cm}^{-1}$ to 1713 cm^{-1} region accompanied by extensive fiber cracking.

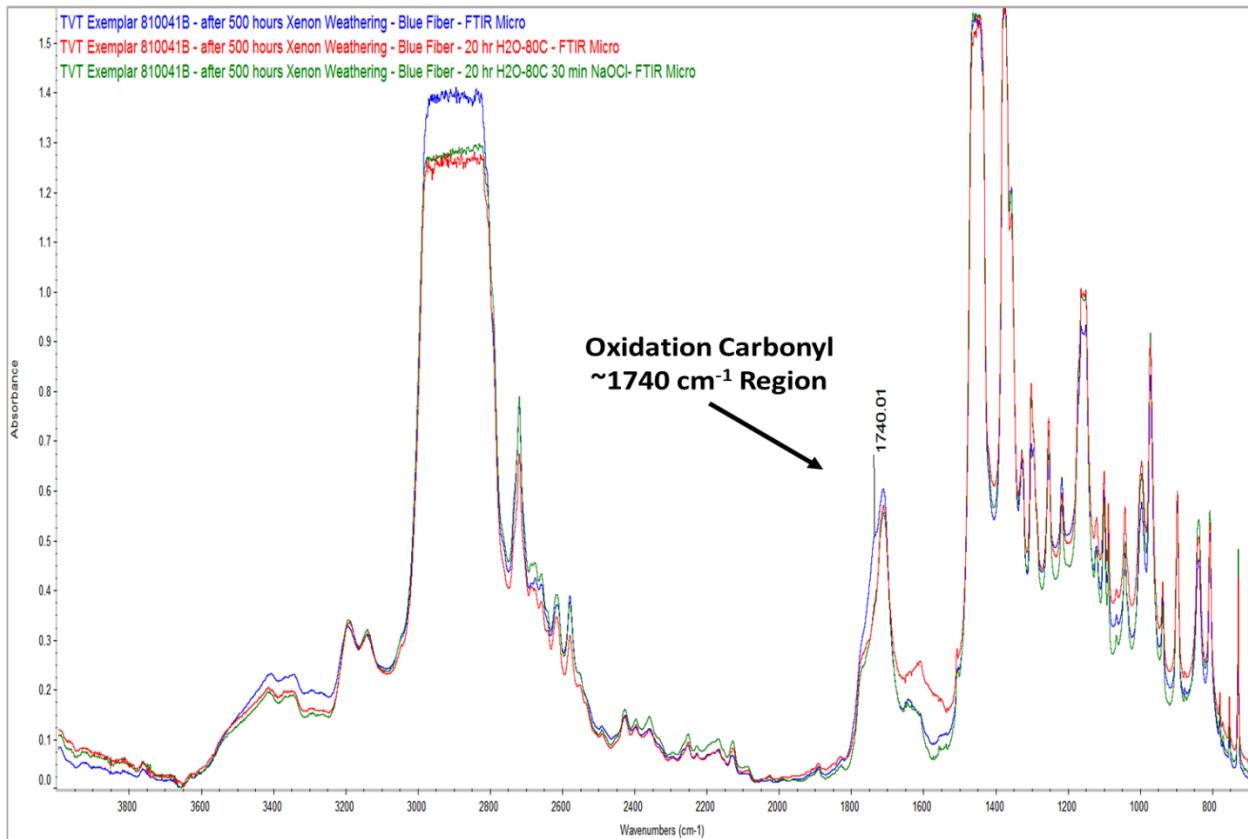
Figure 8. Overlay of Blue Fiber TTV Exemplar 810041B – After 500 hrs. Xenon Exposure (Blue Spectrum), After 20 hrs. Immersion in 80°C water (Red Spectrum), and After 30 min. Immersion in NaOCl (Green Spectrum)

Consequently, the oxidized TTV exemplar (Figure 7) was immersed in 80°C water for 20 hours, removed, dried, and analyzed via FTIR microscopy (Figure 8 – red spectrum). The oxidized TTV exemplar was then immersed in sodium hypochlorite solution (NaOCl) on a shaker for 30 minutes, removed, dried, and again analyzed via FTIR microscopy (green spectrum). Although there was no flesh present to utilize sodium hypochlorite's oxidizing capacity, the FTIR spectral overlay demonstrates that carbonyl (oxidation) absorption did not diminish during, and as a result of, the cleaning protocol (Figure 8). The cleaning process (Fig. 1) was continued, utilizing the intentionally oxidized TTV exemplar, with FTIR analyses conducted after each cleaning stage (see Figures 8 and 13).

The FTIR spectra of Figure 13 unequivocally verifies that the cleaning protocol of Figure 1 does not remove oxidized carbonyl moieties from Prolene. Moreover, should oxidized Prolene be present it will be seen as a strong carbonyl frequency at or near ~1740 cm⁻¹ (Figure 8)

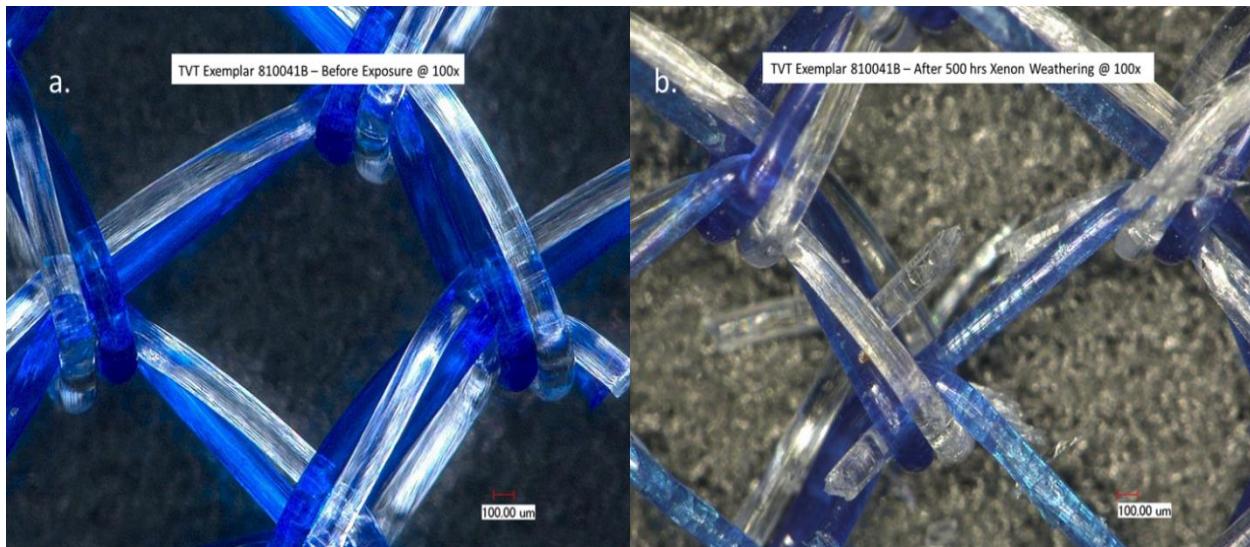
Figure 11. Light Microscopy of TVT 810041B Exemplar before UV exposure (a.) and after 500 hrs. UV exposure (b.)

Digital microscopy and scanning electron microscopy (SEM) of the before and after fiber exposure samples were conducted with a Keyence VHX-600 digital microscope (Figure 9) and a Zeiss Sigma VP FEG-SEM (Figure 10). One can readily observe oxidation effects upon Prolene as demonstrated by light microscopy and SEM fiber images (Figures 11 and 12, respectfully); before and after UV exposure. As a result of UV exposure, as described herein, Prolene fibers were grossly embrittled and demonstrated deep cracks resulting in fiber rupture via crack propagation.

Note the extensive fiber cracking and flaking; the product of crack propagation. Clearly the physical properties of Prolene have been severely compromised by UV light exposure (i.e. oxidative degradation).

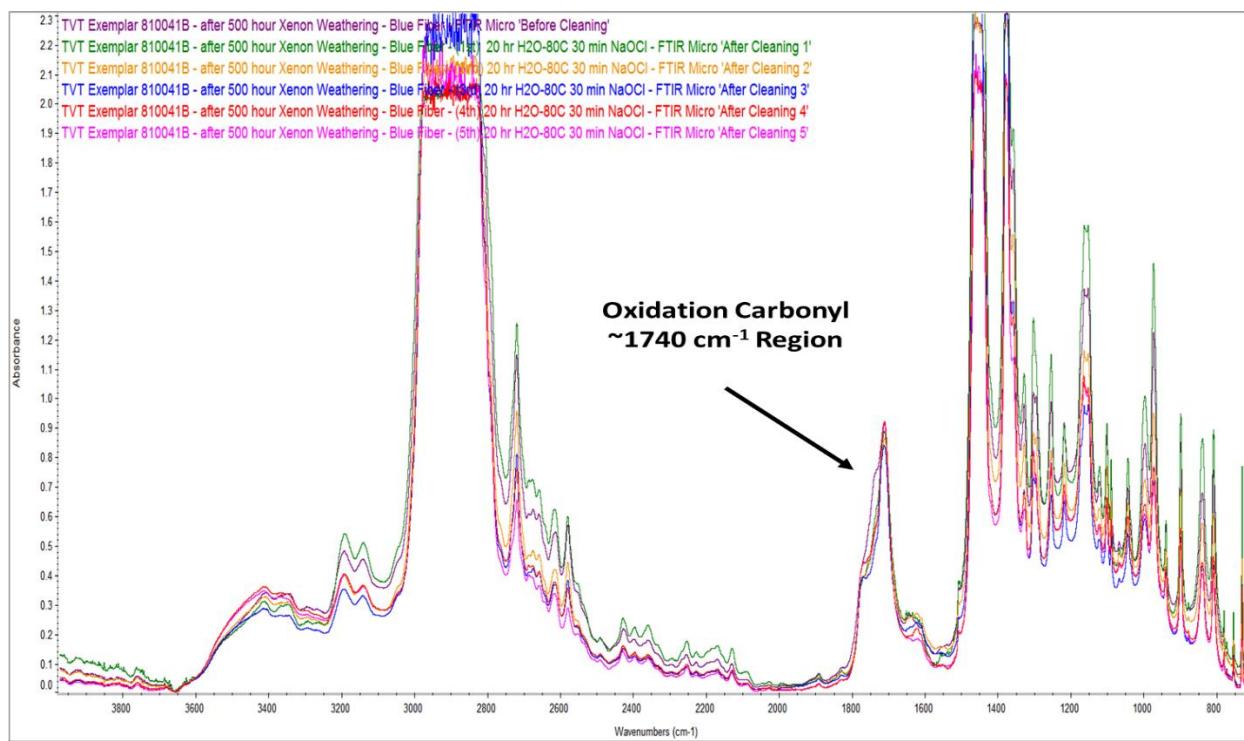
Figure 13. FTIR Spectral overlay of intentionally oxidized Prolene and the same sample after each of the cleaning steps highlighted in Figure 1.

The FTIR spectral overlay of Figure 13 confirms the carbonyl oxidation absorption of the intentionally oxidized Prolene sample has not diminished with progressive cleaning. This further proves the cleaning protocol does not deplete the carbonyl absorption of oxidized Prolene, should it be present in explanted samples.
